# Reactor Core Status of Fukushima Daiichi Nuclear Power Station Unit 1

May 15<sup>th</sup>, 2011

Tokyo Electric Power Company

# Provisional Analysis Result

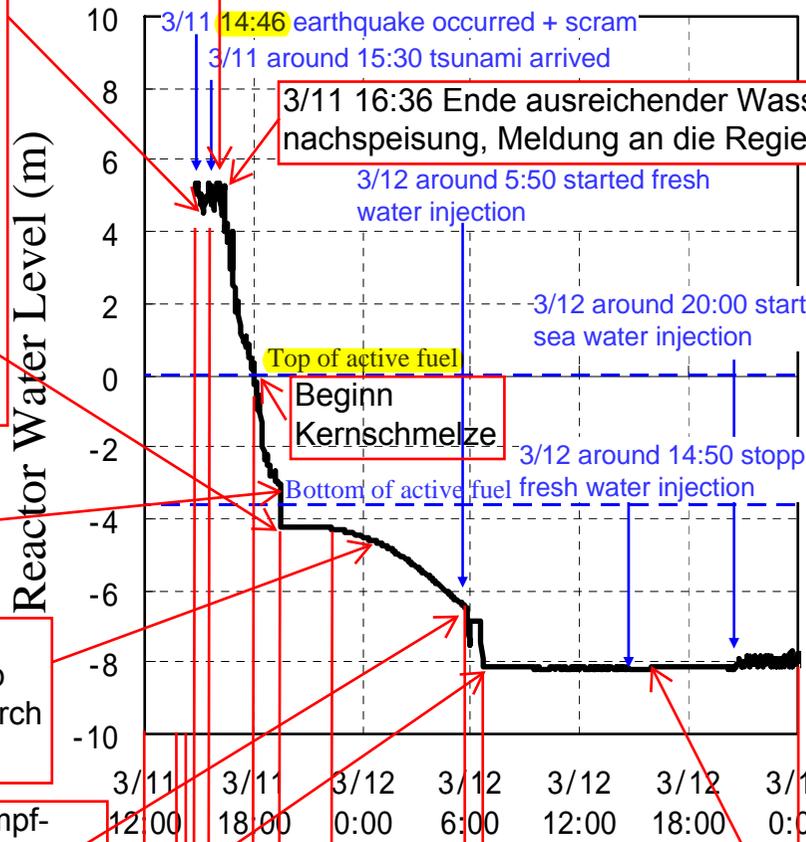
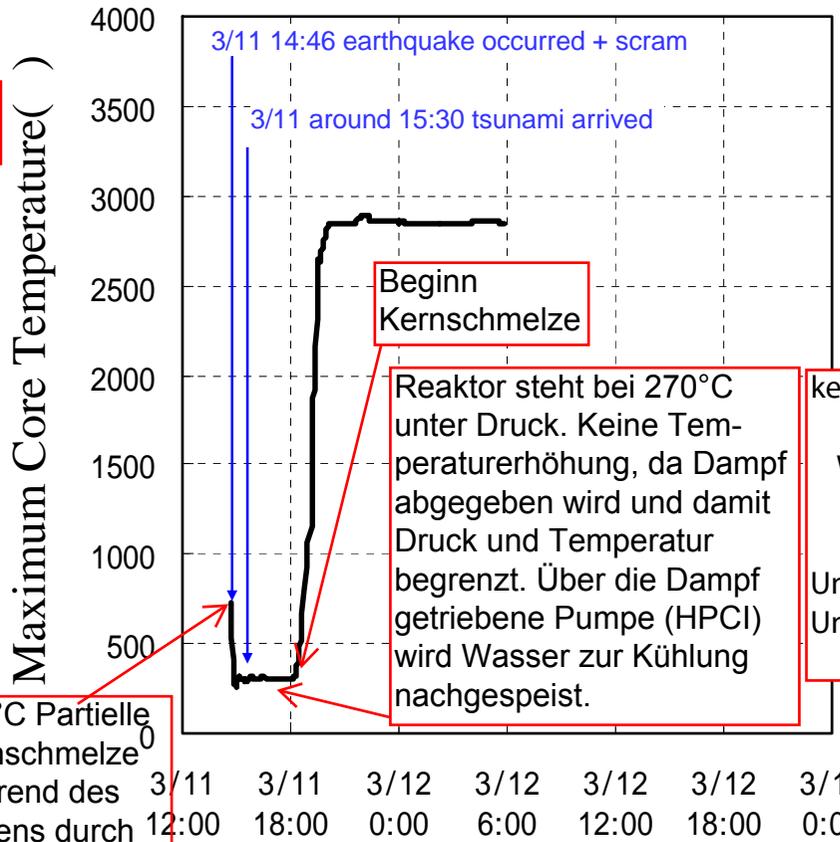
# Fukushima-Daiichi Unit 1: Reactor Water Level, Maximum Core Temperature (Analysis Result)

Key assumption: IC lost its function after the tsunami arrived at around 15:30

- reached top of active fuel in 3 hours (around 18:00) after the **scram**  
- reached bottom of active fuel in 4 and a half hours (around 19:30) after the **scram**

The **core temperature** started increasing when the reactor water level became **lower than top of active fuel**, then reached the core melting temperature.

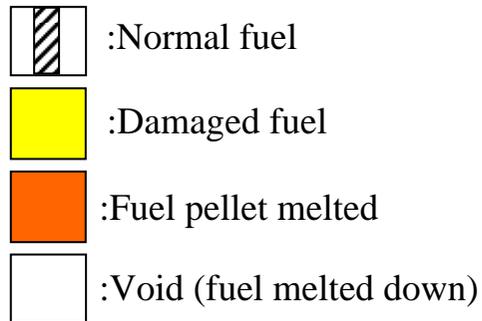
## Degree of fuel damage

- Melting starts from the central part of the core.
- In 16 hours after scram (around March 12th 6:50), most part of the core fell down to the RPV bottom.
- Although RPV is damaged in this provisional analysis, the actual damage of RPV is considered to be limited according to the temperatures presently measured around the RPV.

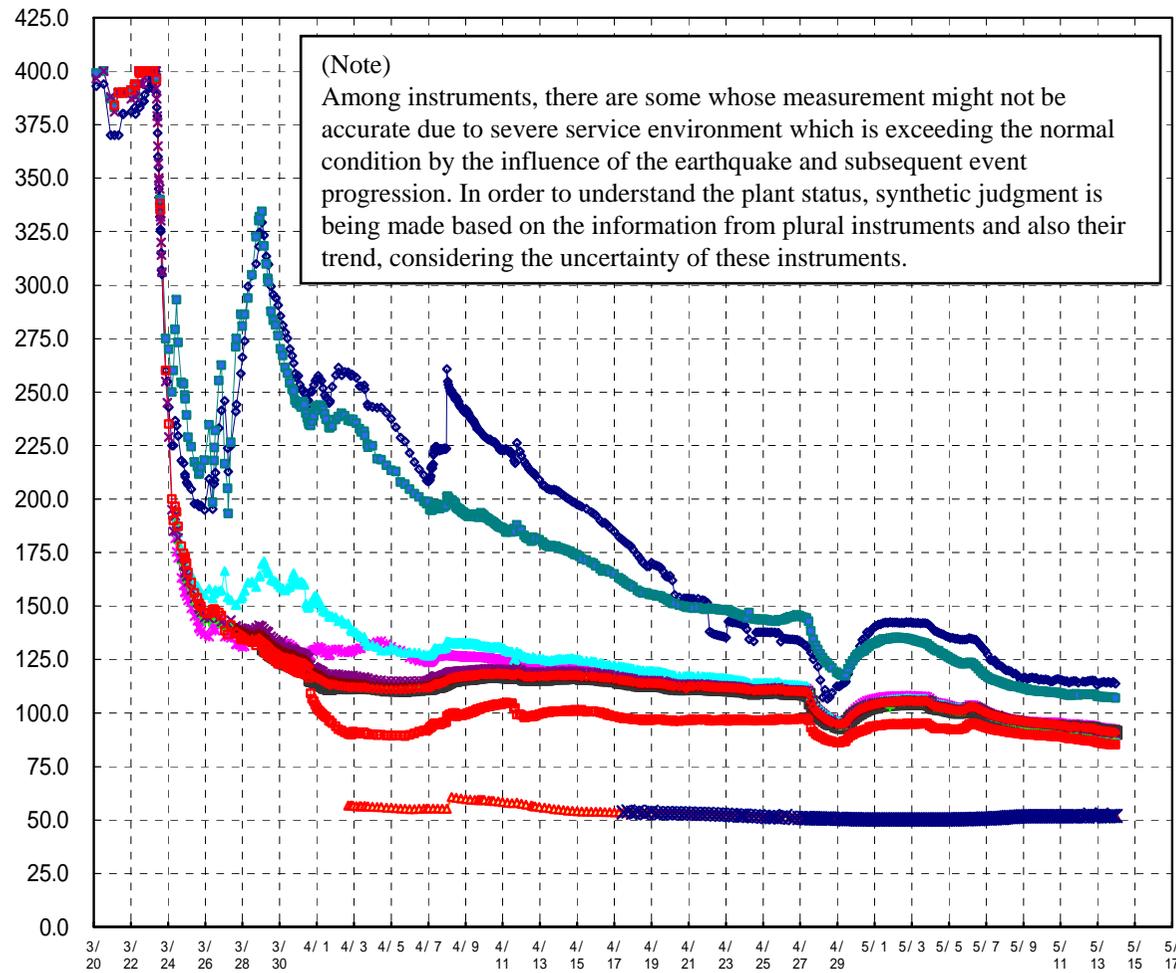
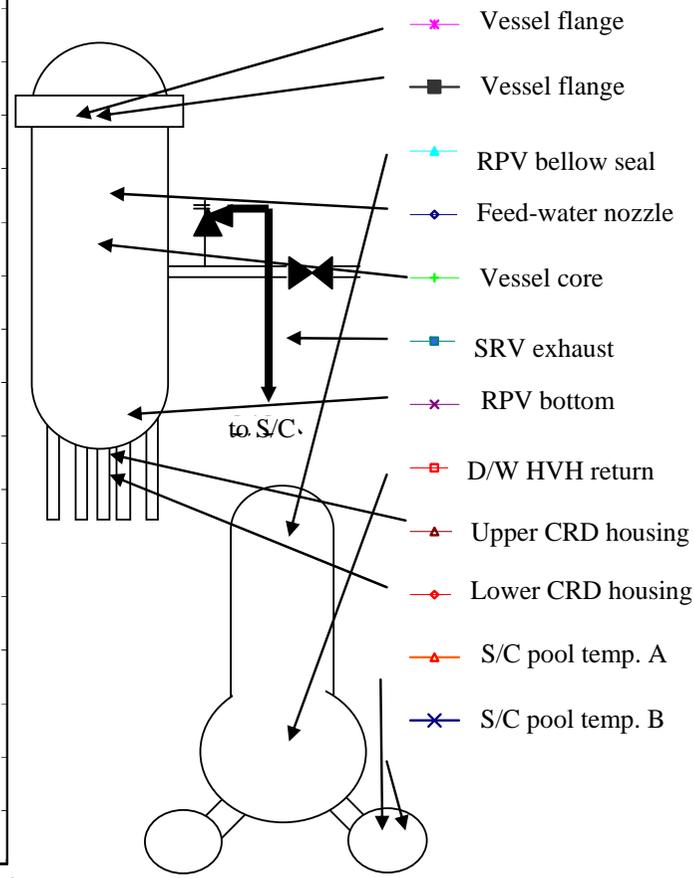
# Unit 1: Temperatures around RPV (actual measurement value)

- **The temperatures around RPV are being measured by differently-located instruments and the indications of operable instruments show a similar trend or temperatures.**

- RPV temperature is around 100 ~120 and the core is stably cooled.
  - Feedwater nozzle temperature is relatively high and this is considered to be the influence of the generated superheated steam from where some part of fuels are exposed in RPV.

- Temperatures of upper and lower part of CRD housing and also RPV bottom can be measured and they are showing a similar tend of temperature.
- **Therefore, considering the above, the fuels are considered to be sufficiently cooled inside the RPV.**
